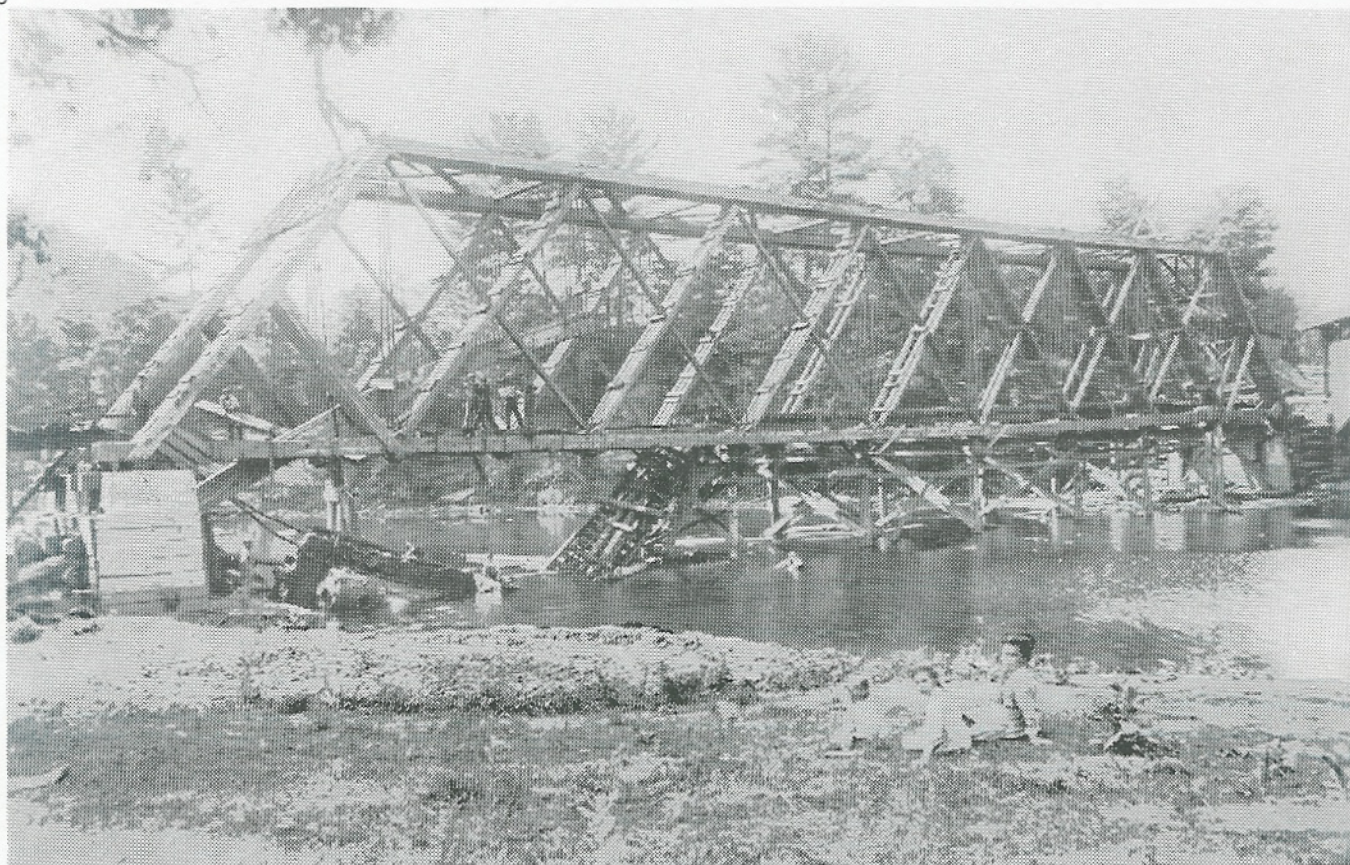
The wooden covered bridge, previous page, in the process of being razed after the locomotive fell through the left hand side of the bridge.

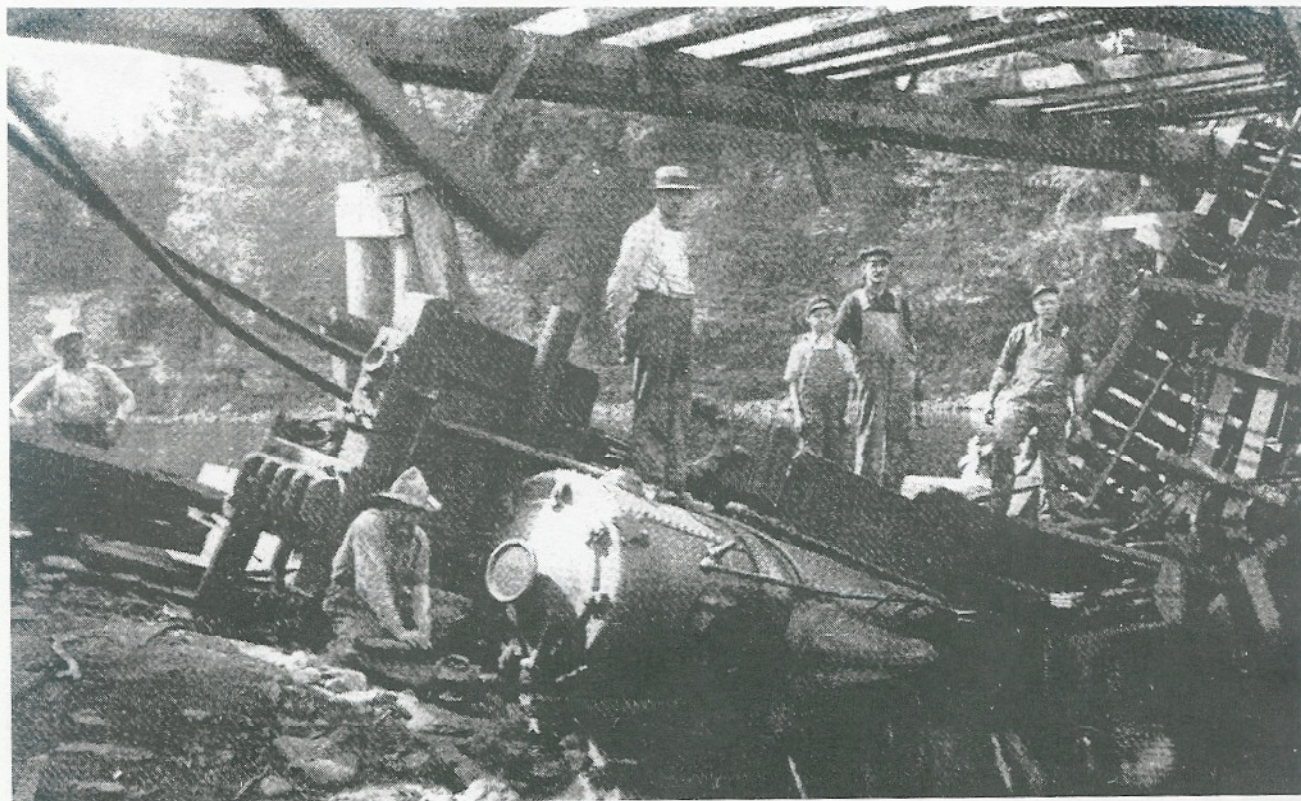
"Dinky in the drink" as this photo is often labeled. The engine was brought right side up and a ramp of temporary track was built to pull it back onto the grade. The wooden bridge was replaced by a steel bridge.
